DEPARTMENT OF TRANSPORTATION

Office of Structural Materials

Contract #: 04-0120F4Cty: SF/ALA Rte: 80 PM: 13.2/13.9File #: 1.28**WELDING INSPECTION REPORT****Resident Engineer:** Pursell, Gary**Address:** 333 Burma Road**City:** Oakland, CA 94607**Report No:** WIR-015708**Date Inspected:** 19-Jul-2010**Project Name:** SAS Superstructure**OSM Arrival Time:** 600**Prime Contractor:** American Bridge/Fluor Enterprises, a JV**OSM Departure Time:** 1500**Contractor:** American Bridge/Fluor Enterprises, a JV**Location:** Job Site**CWI Name:** See below**CWI Present:** Yes No**Inspected CWI report:** Yes No N/A**Rod Oven in Use:** Yes No N/A**Electrode to specification:** Yes No N/A**Weld Procedures Followed:** Yes No N/A**Qualified Welders:** Yes No N/A**Verified Joint Fit-up:** Yes No N/A**Approved Drawings:** Yes No N/A**Approved WPS:** Yes No N/A**Delayed / Cancelled:** Yes No N/A**Bridge No:** 34-0006**Component:** SAS OBG**Summary of Items Observed:**

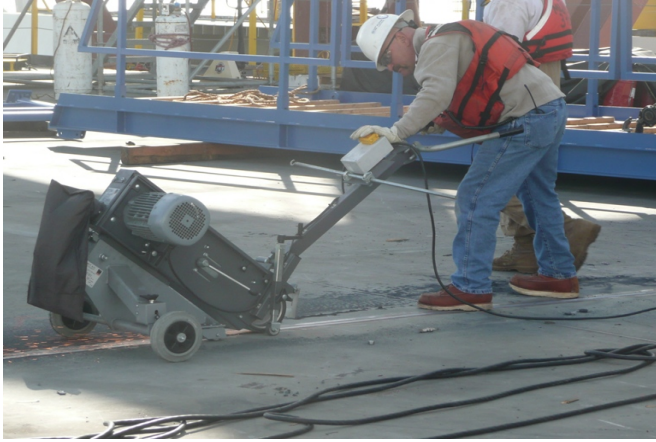
5W/6W-D

The QA Inspector randomly observed the ABF welder Bryce Howell remove the fit up gear from the bottom side of the above identified weld joint. The QA Inspector noted the weld joint had only been tack welded from the inside, and the root pass or subsequent weld passes had not been deposited. The ABF welder informed the QA Inspector, he needed to remove the fit up gear to install the induction heat blankets in preparation of the submerged arc welding (SAW). Upon the arrival of the QA Inspector Danny Reyes and Jojo Lizardo, the QA Inspector informed the QA Inspectors to randomly verify the fit up did not move or shift after the fit up gear was removed. In addition the QA Inspector informed the QA Inspectors to randomly check the full length tack welds for any indication of shifting members.
